**AUSTRALASIAN INSTITUTE OF
ENGINEER SURVEYORS INC.**

GAZETTE

MARCH 2018
Volume 28 Issue 1

Analysis of the Catastrophic Rupture of a Pressure Vessel

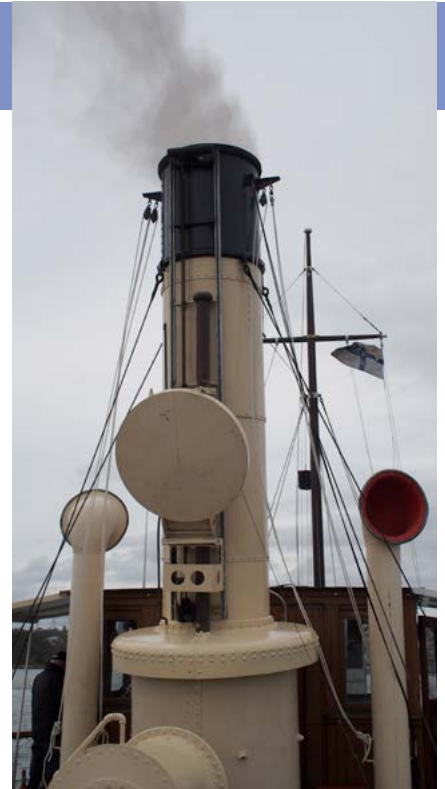
Coal-fired Scotch Marine Boilers produce steam at 827 kPa supplying the compound steam engine

The two furnace coal-fired Scotch Marine Boilers produce steam at 827 kPa supplying the compound steam engine which delivers 205 KW of engine power at full output!

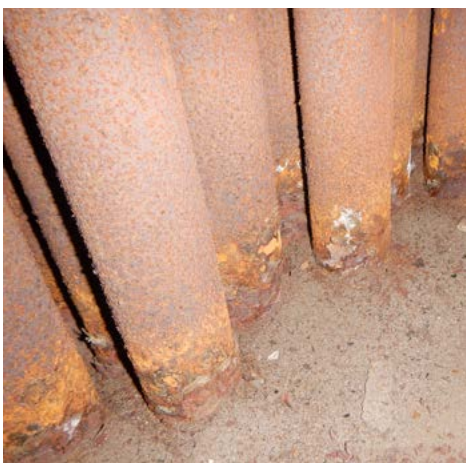
Tubular air heater shown prior to cleaning the air-side of the tube bottom ends. Perforations were found at the tubes after cleaning

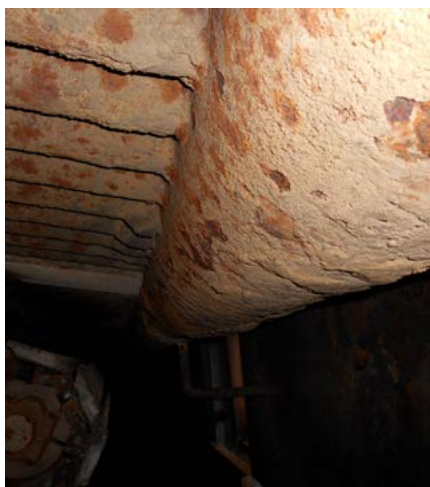
Header tube stubs prior to preparation for inspection and NDT

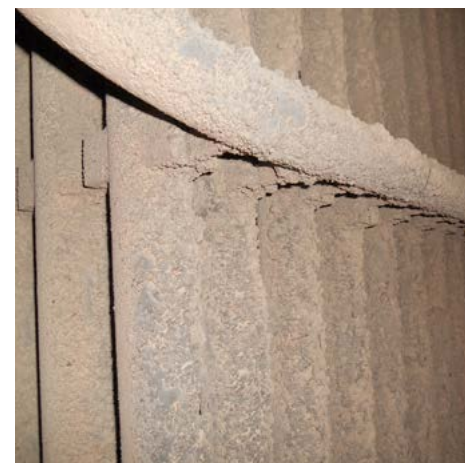
Tube attachment welds which are encrusted with debris. Neither visual inspection nor NDT are possible in this condition
